US ARMY
LABORATORY COMMAND
MATERIALS TECHNOLOGY
LABORATORY

NONDESTRUCTIVE EVALUATION OF METAL MATRIX
COMPOSITES

S. W. SCHRAMM, G. M. KOLLER and J. W. ADAMS
IIT Research Institute
10 West 35th Street
Chicago, IL 60616

FINAL REPORT

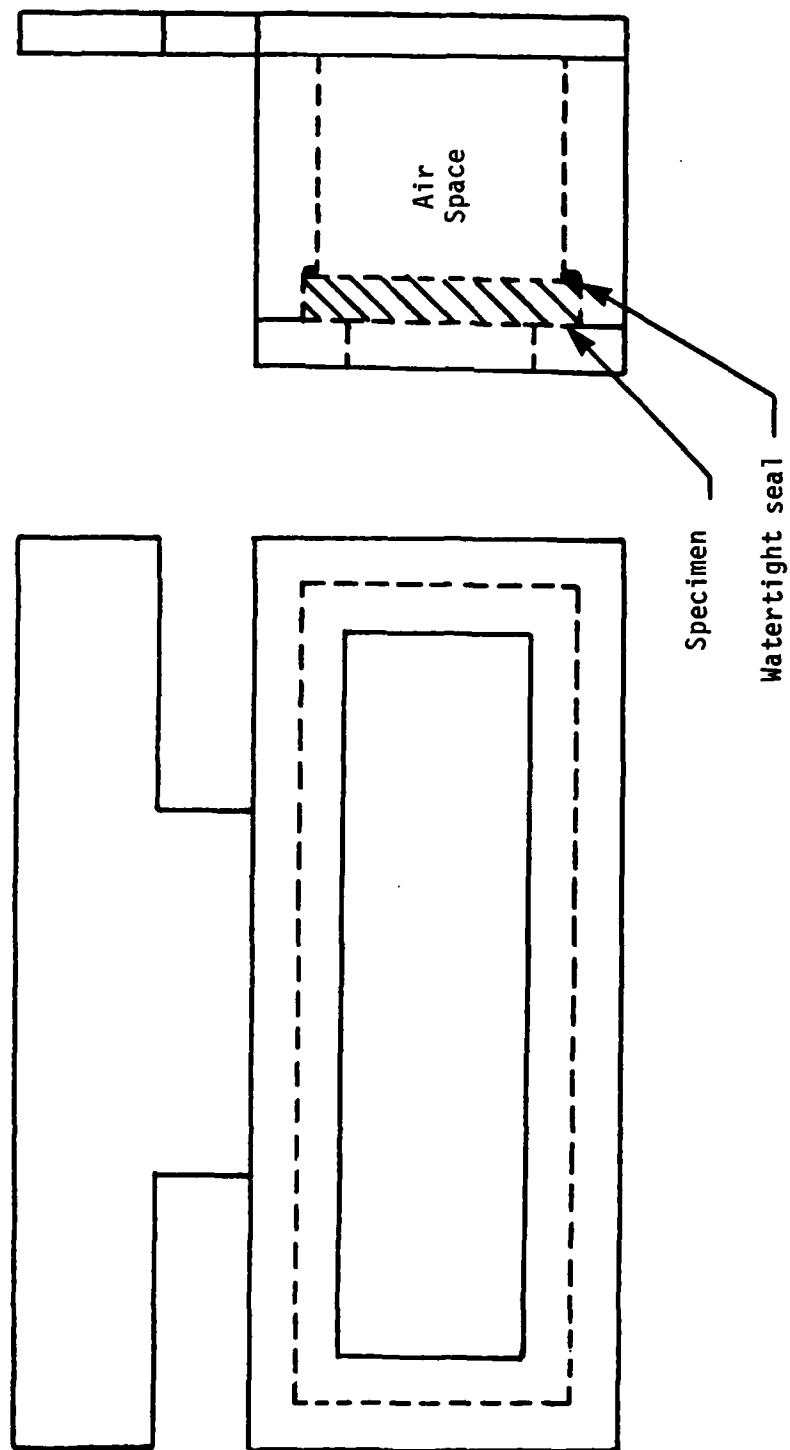
Figure 3. Specimen holder for determination of ultrasonic wave attenuation of FP/Mg specimens.

and the energy dissipation in the couplant between the transducer and the specimen. The specimen holder shown in Figure 3 was designed¹¹ to minimize ultrasonic wave energy losses associated with the transmission of ultrasound to the water through the back face of the coupon during immersed ultrasonic inspection. The specimen holder had a watertight seal which formed an air pocket adjacent to the back face of the coupon. Since the impedance mismatch was greater between FP/Mg and air than between FP/Mg and water, less wave energy was lost through the back face to the air than would occur if the coupon was totally surrounded by water.

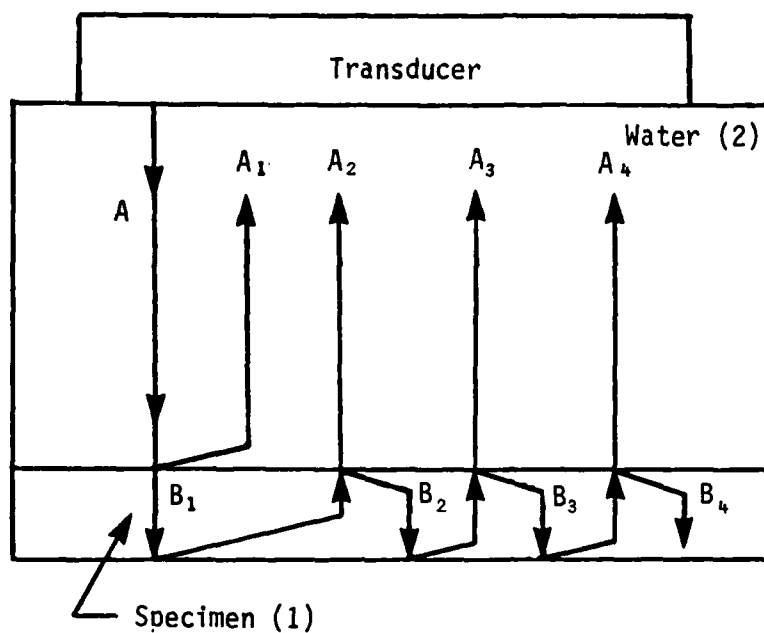
<u>Time After Initial Pulse</u>	<u>Pulse</u>	<u>Magnitude</u>
0	A	A
$2t_2$	A ₁	$AR_{21}10^{-\alpha_2}$
$2t_2 + 2t_1$	A ₂	$AT_{21}T_{12}R_{10}10^{-\alpha_2-\alpha_1}$
$2t_2 + 4t_1$	A ₃	$AT_{21}T_{12}R_{10}^2R_{12}10^{-\alpha_2^2-\alpha_1}$
$2t_2 + 6t_1$	A ₄	$AT_{21}T_{12}R_{10}^3R_{12}^210^{-\alpha_2^3-3\alpha_1}$

Figure 4. Schematic of echoes received by transducer.

Figure 4 schematically shows the pulses received by the transducer where:

Taking the logarithms of the amplitude ratios of the various echoes shown in Figure 4 and setting $R_{10} = 1$, we obtain:

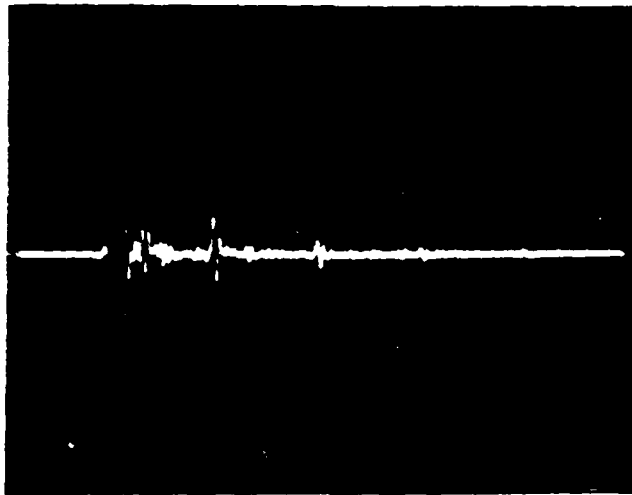
<u>Inspection Location</u>	<u>Amplitude (Volts)</u>	<u>Time (10^{-6} s)</u>
1	1.90	0.00
2	0.49	1.75
3	0.10	3.50
4	0.05	5.25

Figure 5. Ultrasonic attenuation record for TP/Mg specimen at an unflawed location.

Figure 5 shows a typical ultrasonic measurement record (A-scan) and corresponding amplitudes. The amplitudes were determined using a digital voltmeter, variable voltage power supply, and a dual beam oscilloscope. The amplitude voltages were determined by using one beam of the oscilloscope as a

A second method of determining the ultrasonic attenuation used a 10 MHz, shear wave, contact transducer operated in the pulse-echo mode. Ultrasonic attenuation records similar to that shown in Figure 5 were generated and reduced using the equations previously presented. Propylene glycol ($Z_2 = 2.5 \times 10^6 \text{ kg/m}^2\text{s}$) was used as the acoustic couplant.

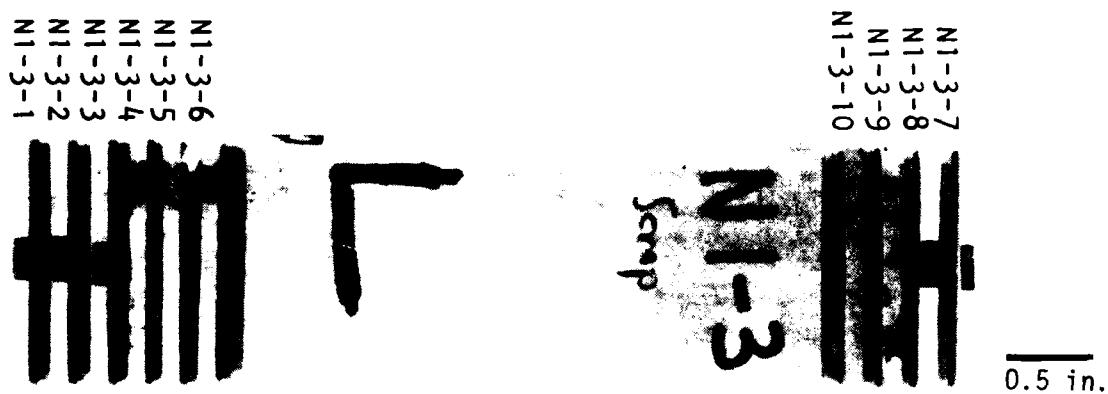
Figure 6. 90° 3-point bend specimen locations from parent coupon N1-3 (porosity).

Parent coupon N1-3, Type 1 porosity, was initially chosen for machining the ten required 90° three-point bend specimens. The bend specimen locations, N1-3-1 through N1-3-10, are shown in Figure 6. Specimens N1-3-1 through N1-3-6 were machined consecutively from the left (flawed) end of the parent coupon, which had an indicated area of uniform porosity extending approximately 18 mm (0.71 in.) in from the left edge. Unflawed specimens N1-3-7 through N1-3-10 were machined consecutively from the right end of parent coupon N1-3. The specimens were rough cut approximately 0.5 mm (0.020 in.) over final dimensions with a 0.5 mm (0.020 in.) wide diamond saw blade, and the sides were ground parallel to the final nominal width of 2.54 mm (0.10 in.).

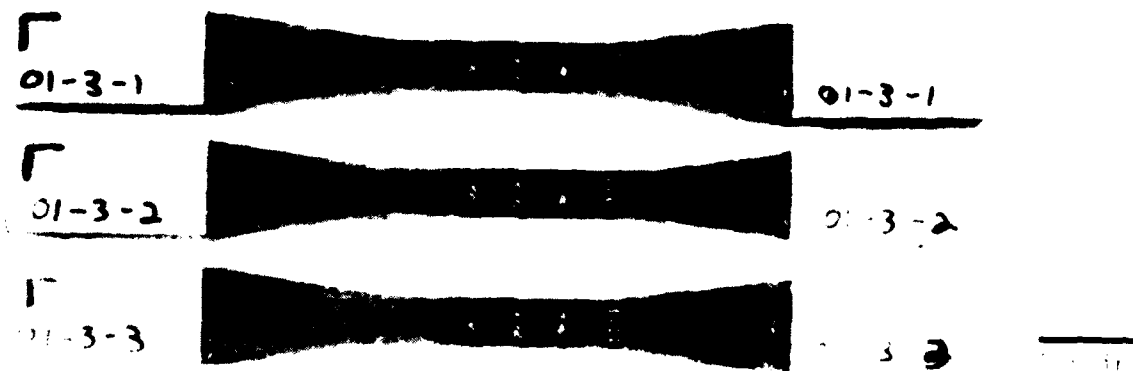
Figure 10. 0° tensile specimen locations from parent coupon 01-3 (unflawed).

Unflawed coupon 01-3 was machined into three 0° tensile specimens consuming the entire coupon. Specimen 01-3-1 was located in the top one-third, specimen 01-3-2 the center third, and specimen 01-3-3 was located in the bottom third of the parent coupon. Figure 10 shows the relative orientation of the tensile specimens from coupon 01-3.

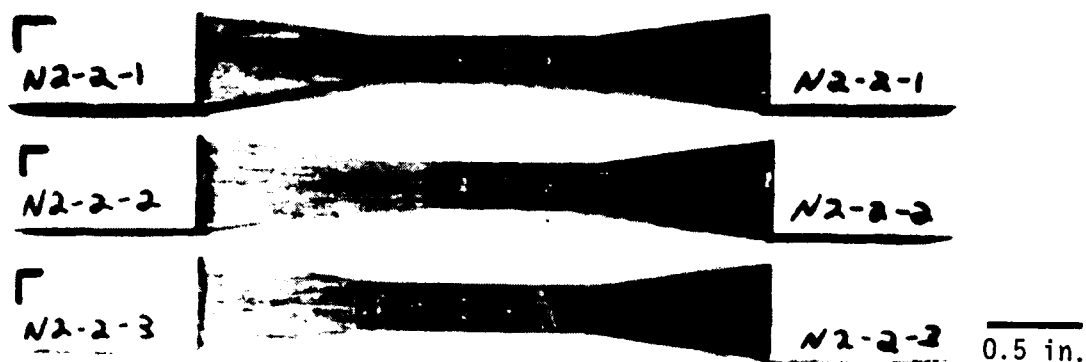
Figure 11. 0° tensile specimen locations from parent coupon N2-2 (nonuniform fiber volume ratio).

Nonuniform fiber volume ratio coupons N2-2 and N2-3 were machined into six 0° tensile specimens consuming both coupons. Specimen N2-2-1 was located in the top one-third of the parent coupon (N2-2). Specimen N2-2-2 was located in the center of the parent coupon (N2-2) and was held in reserve as a spare specimen. Specimen N2-2-3 was located in the bottom third of the parent coupon (N2-2). Figure 11 shows the relative orientation of the three tensile specimens from coupon N2-2. Figure 12 shows the relative orientation of the three tensile specimens from coupon N2-3 (similar to N2-2). The interface of the 35% and the 55% fiber volume ratios for all six of the Type 2 tensile specimens was contained within the gage section.

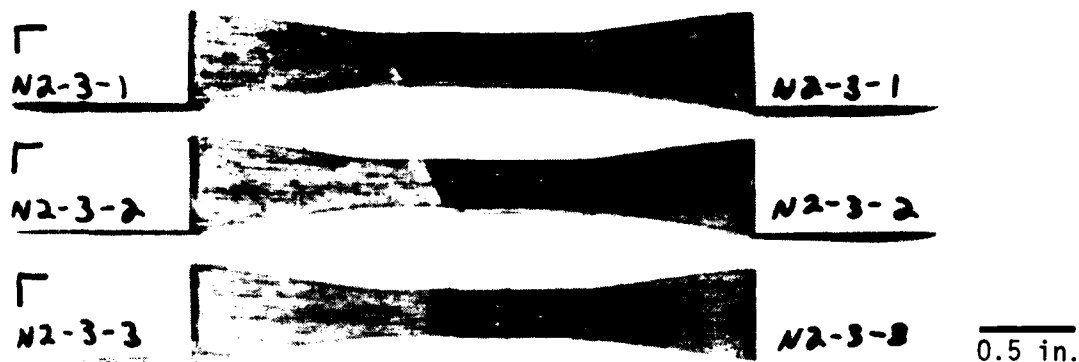
Figure 12. 0° tensile specimen locations from parent coupon N2-3 (nonuniform fiber volume ratio).

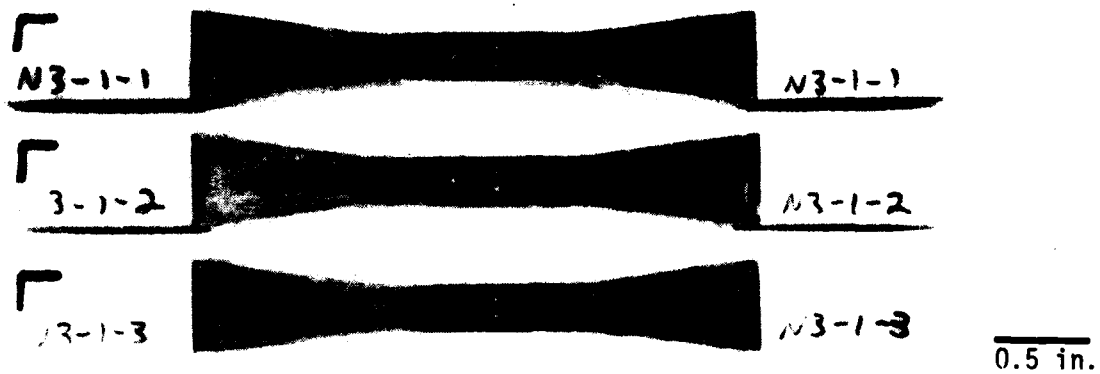
Figure 14. 0° tensile specimen locations from parent coupon N3-1 ($\pm 20^\circ$ off-axis fibers).

Coupon N3-1, with internal $\pm 10^\circ$ off-axis plies, was machined into three 0° tensile specimens consuming the entire coupon. Figure 13 shows the relative orientation of the three tensile specimens from coupon N3-1. Coupon N3-3, with internal $\pm 20^\circ$ off-axis plies, was machined into three 0° tensile specimens consuming the entire coupon. The specimen orientation is shown in Figure 14.

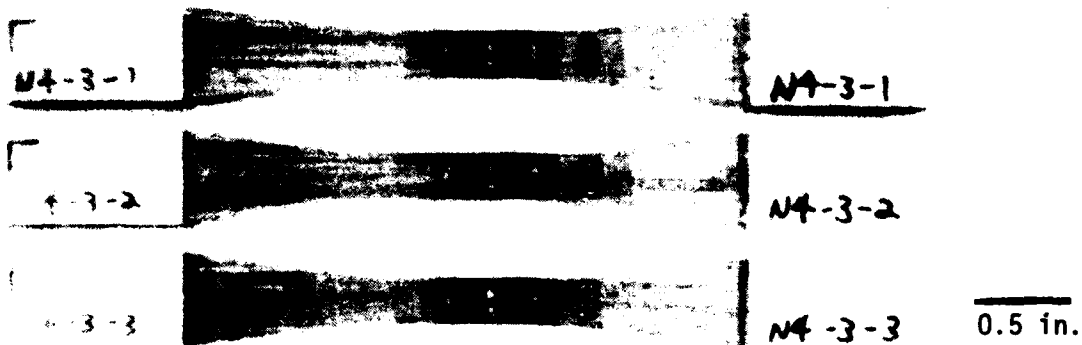
Figure 16. 0° tensile specimen locations from parent coupon N4-3
(1/10 in. gap fiber fracture).

Coupon N4-3, with a 2.54 mm (0.10 in.) wide internal fiber fracture, one ply thick, also supplied three 0° tensile specimens. Specimen N4-3-1 was located in the top one-third, specimen N4-3-2 was located in the center third, and specimen N4-3-3 was located in the bottom third of the parent coupon (N4-3). Figure 16 shows the relative orientation of the three tensile specimens from coupon N4-3. The intentional flaw of all three of the gap fiber fracture specimens from coupon N4-3 was within the gage section.

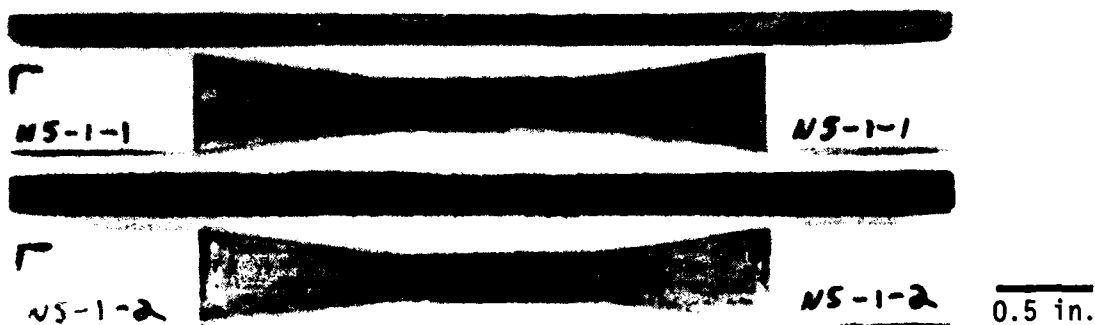
Figure 17. 0° tensile specimen locations from parent coupon N5-1
(fiber/matrix debonding).

Coupon N5-1, Type 5 fiber/matrix debonding, was machined into two 0° tensile specimens containing defects in the gage section. Specimen N5-1-1 was located in the top portion of the parent coupon 3.17 mm (0.125 in.) down from the top edge. Specimen N5-1-2 was removed from the bottom third of the parent coupon (N5-1). Figure 17 shows the relative orientation of the two tensile specimens from coupon N5-1.

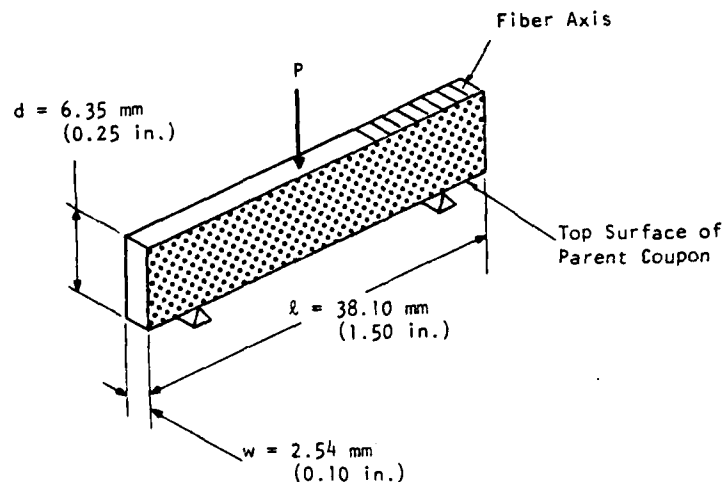
90° 3-point bend specimens, loaded perpendicular to fiber direction:

The 90° three-point bend specimens were removed from their parent coupons with a diamond saw blade. The as-cut specimens were approximately 0.5 mm (0.020 in.) over the nominal width of 2.54 mm (0.10 in.) to allow for grinding the cut sides parallel. The narrow dimension of the specimens was produced by grinding the saw-cut sides parallel. This produced a rectangular beam of nominal dimensions 2.54 mm (0.10 in.) x 6.35 mm (0.25 in.) x 38.10 mm (1.50 in.) long. The 90° bend specimens tested perpendicular to the fiber direction were oriented such that their width was 2.54 mm (0.10 in.) and their depth was 6.35 mm (0.25 in.). The 90° bend specimens tested parallel to the fiber direction were oriented such that their width was 6.35 mm (0.25 in.) and their depth was 2.54 mm (0.10 in.). The length of the bottom span was 25.4 mm (1.00 in.). All of the 90° three-point bend specimens were oriented such that the top face of the parent coupon was the tensile surface in the bend tests for the specimens loaded perpendicular to the fiber direction. The orientations are illustrated in the following sketches.

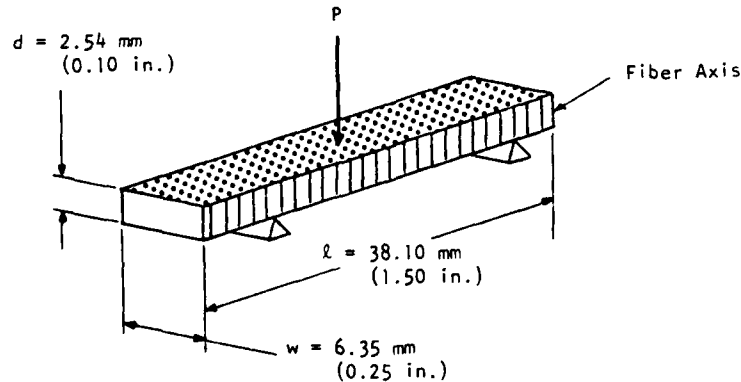
90° 3-point bend specimens, loaded parallel to fiber direction:

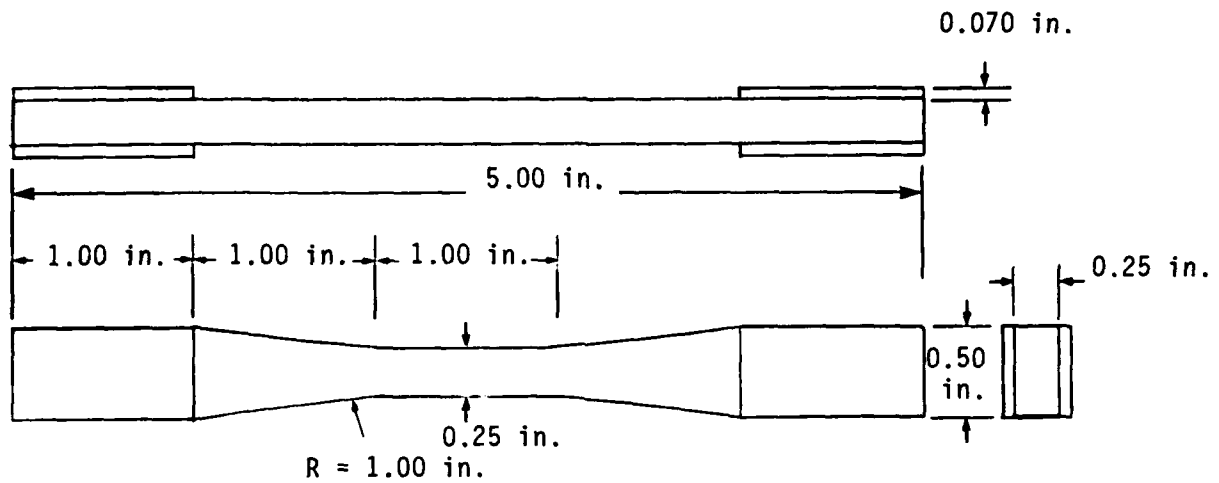
(a) Design A configuration used for 01-3, N2-2, N2-3, N3-1, N3-3, N4-3, and N5-1 tensile specimens.

Figure 18. Tensile specimen geometries recommended in ASTM D-3552.¹³

The 0° tensile specimens were removed from the parent coupons by slicing the parent coupon into thirds along its length of 127 mm (5.0 in.) using electric discharge machining (EDM). This method was used rather than diamond sawing in order to remove as little material as possible between specimens. EDM was used to rough out the approximate specimen geometry in both the gage section and the transition section between the tab area and gage section. Final tensile specimen geometry was obtained by diamond wheel grinding to the specimen profile as recommended by ASTM D-3552, "Standard Test Method for Tensile Properties of Fiber-Reinforced Metal Matrix Composites."¹³ All of the 0° tensile specimens, except those from coupon N4-1, were machined to the specifications of ASTM D-3552 flat tension specimen design "A" with the following modification: specimen design "A" calls for a tab width, W_t , of $2T + W_G$, where T = specimen thickness 6.35 mm (0.25 in.), and W_G = width of the gage section 6.35 mm (0.25 in.). This would require a tab width of 19.05 mm (0.75 in.). The 38.10 mm (1.50 in.) width of the parent coupons limited the tab width of the tensile specimens to less than 12.70 (0.5 in.). Flat tension specimen geometry for design "A" is shown in Figure 18a.

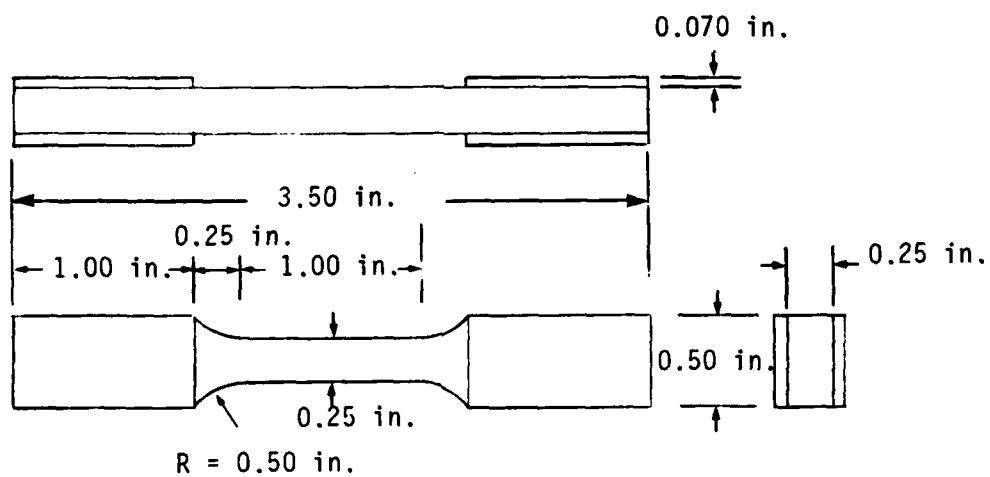
(u) Design E specimen configuration used for N4-1 tensile specimens

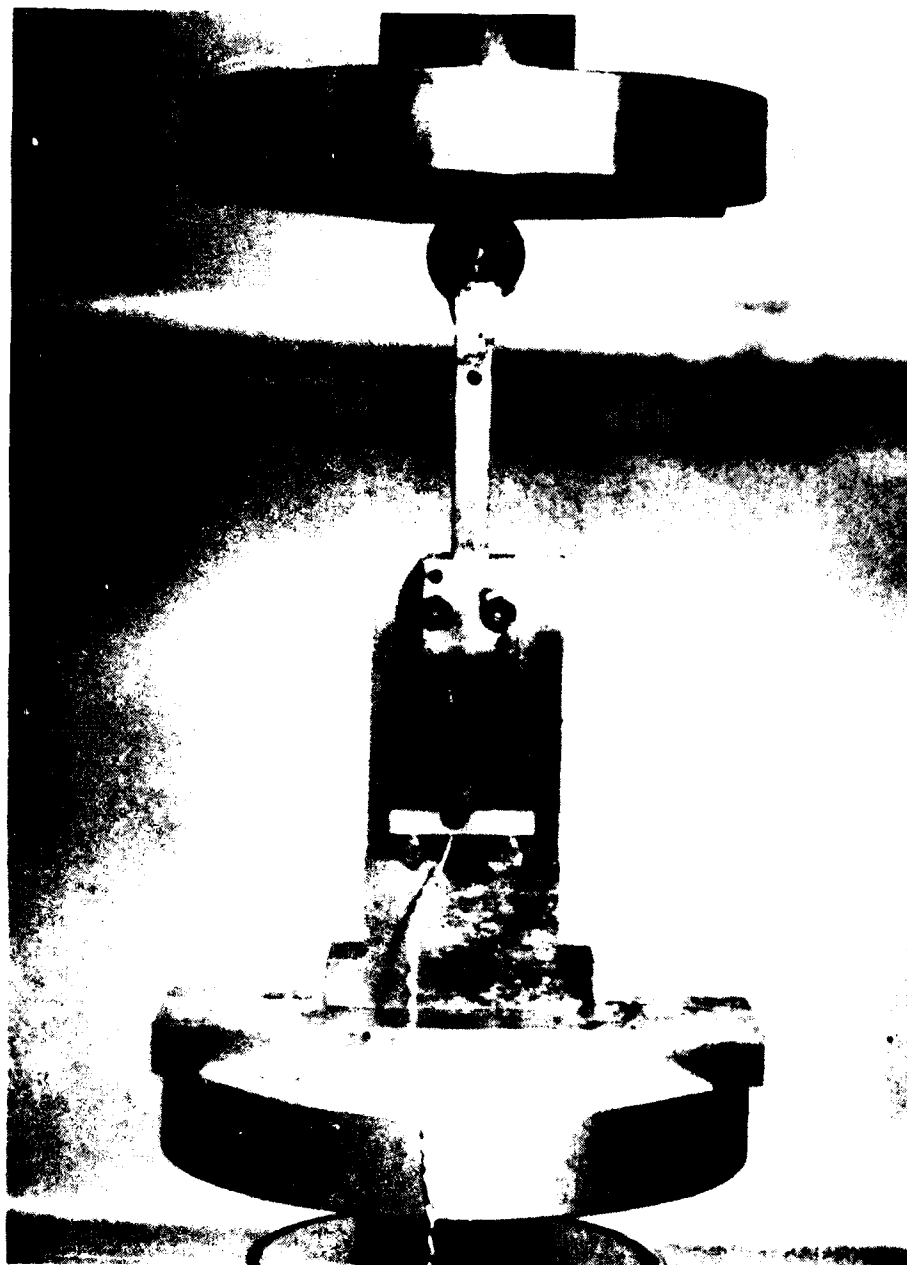
*Figure 19. 3-point flexure fixture with specimen in place
in an Instron test machine.*

The three-point bend specimens were instrumented with a single strain gage (Micro Measurements Type EA-15-062DF-120) at the center of the tensile face to monitor the tensile strains. The strain gage was bonded to the specimen with M-bond Type 200, methyl-2-cyanoacrylate adhesive. After lead wires were soldered to the gage, the gage assembly was coated with M-Coat-A, air-drying polyurethane, for both moisture and mechanical protection. Specimens were tested in an Instron testing machine at a crosshead rate of 0.008 cm/min (0.02 in./min). The applied load and tensile strain were recorded at several intervals to failure. Figure 19 shows the three-point bend test fixture set up in the Instron test machine with a bend specimen in place.

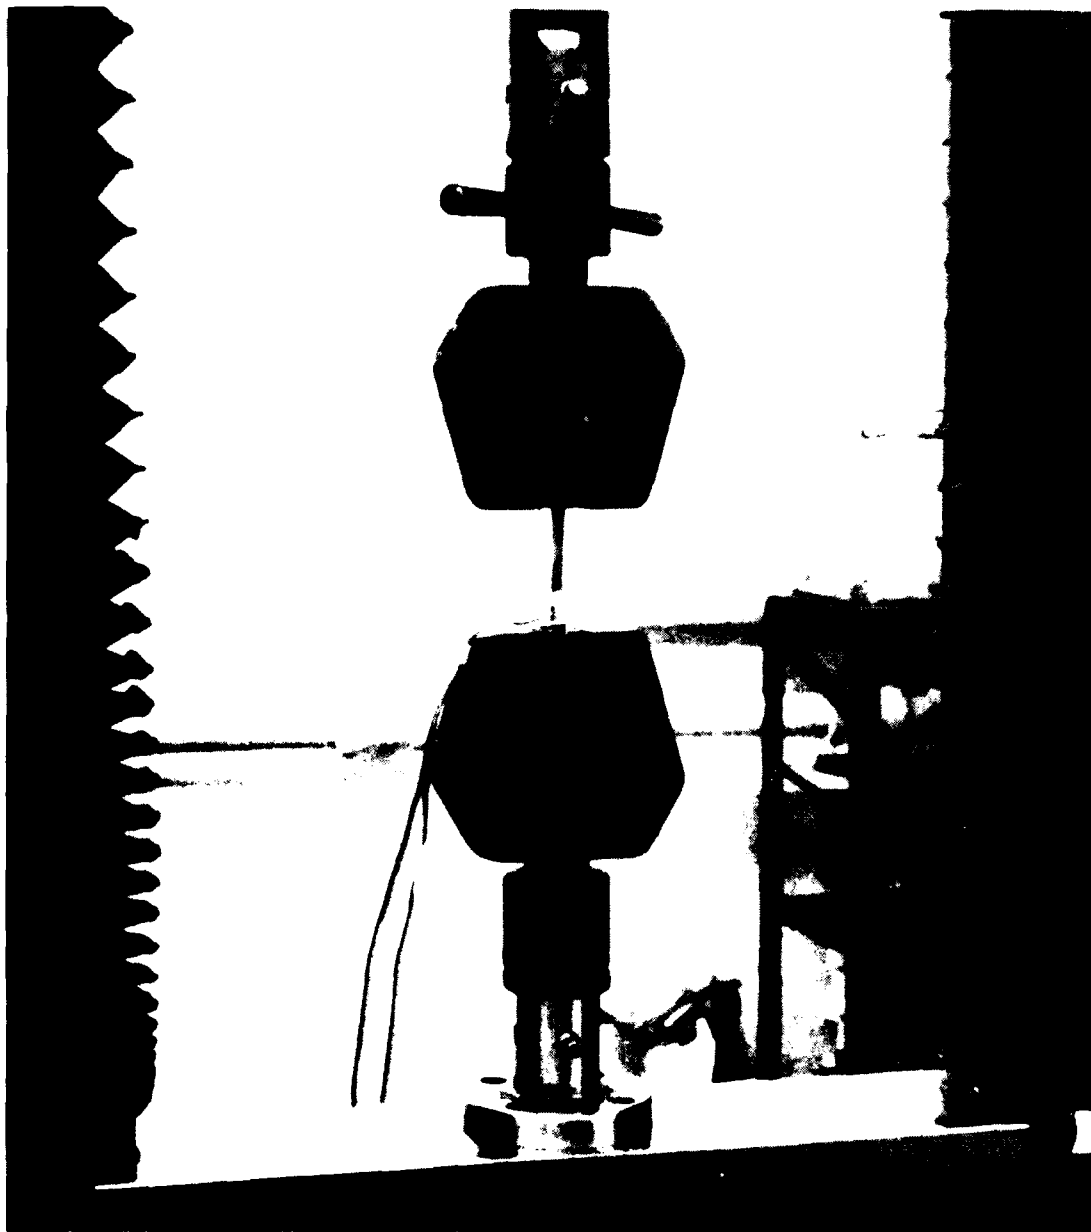
Figure 20. An instrumented tensile specimen illustrating the gripping arrangement for tensile testing in an Instron test machine.

The 0° tensile specimens were instrumented with a two-gage rosette (Micro Measurements Type EA-15-125VB-120) on both the front surface of the gage area and the back surface of the gage area. Each two-gage rosette consists of a longitudinal gage and a transverse gage. The rosette was located such that the longitudinal gage was positioned at the center of the gage section. The longitudinal (0°) gages monitored axial tensile strains in the specimen. The opposite side positioning of the longitudinal gages also monitored the presence of any bending which may have occurred during axial loading. The transverse (90°) gages were used to monitor the transverse contraction of the gage section due to Poisson's strain of the material. The two types of gages permitted the calculation of the elastic modulus, E_{11} , for the material and Poisson's ratio, ν_{12} , as well as strain-to-failure. The strain gages were bonded to the tensile specimens after surface preparation with M-bond Type 200, methyl-2-cyanoacrylate adhesive. After lead wires were soldered onto the gages, the entire gage assemblies were coated with M-coat-A, air-drying polyurethane, for both moisture and mechanical protection. The tensile specimens were tested to failure in an Instron testing machine at a crosshead extension rate of 0.008 cm/min (0.02 in./min). The applied load and corresponding strains were recorded at several intervals to failure. Figure 20 shows the

instrumented tensile specimen as set up in the Instron test machine. Load and strain were monitored with a Kaye datalogger.

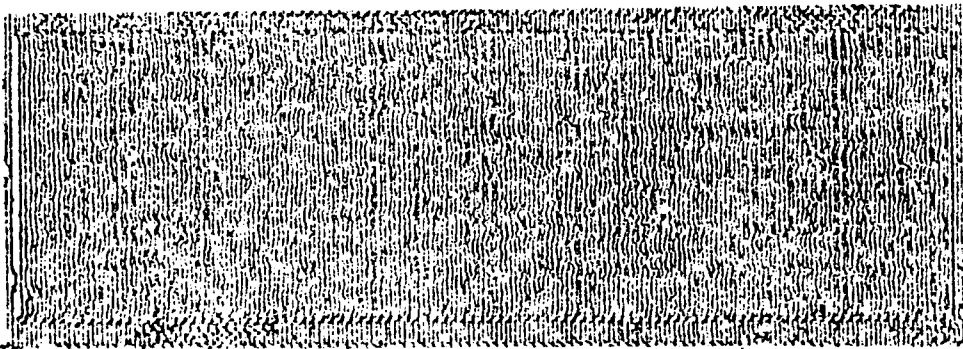
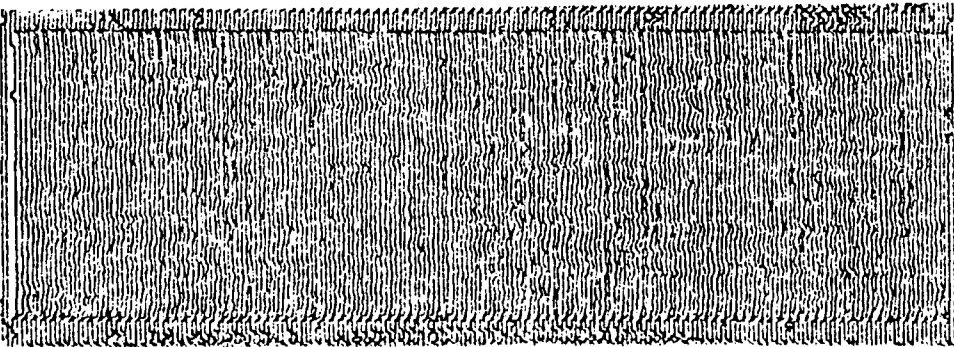
*Figure 21. Detectability/reproducibility analog C-scans
of FP/Mg coupon 01-3 with no intentional flaws.*

Figure 21 shows the detectability/reproducibility analog C-scans for coupon 01-3 with no intentional flaws. As would be expected from an unflawed coupon, the C-scans show uniformly and regularly spaced scan lines with no horizontal deflections indicating the presence of flaws or defects.

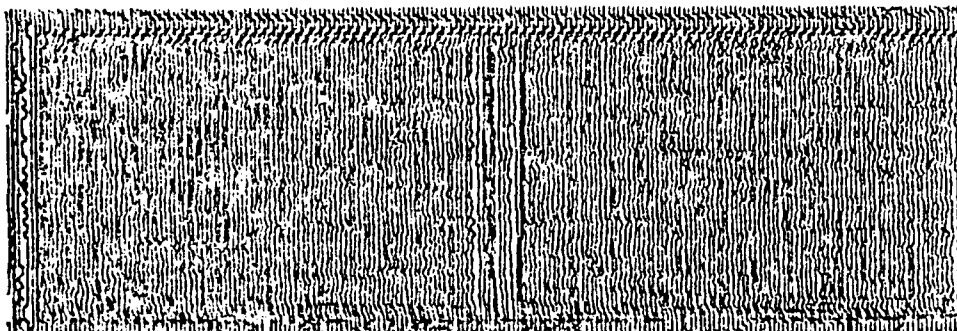
Figure 26 shows the detectability/reproducibility analog C-scans for coupon N4-3 with 2.54 mm (0.1 in.) gap fiber fracture. The three C-scans clearly show the position and extent of the gapped fiber fracture which appears as a vertical band at the center of the coupon. The C-scans show that the gap is slightly wider, approximately 6.4 mm (0.25 in.), than specified for fabrication. It appears that one or both of the gap fiber plies migrated during the casting process causing the change in the gap separation dimension. Again, the defect was easily detected by ultrasonic inspection even though the fiber gap was located at the mid-thickness of the coupon. For FP/Mg coupon N4-3 with a gapped fiber fracture, the ultrasonic inspection reproducibly showed the presence, extent, and location of the fiber fracture.

Figure 26. Detectability/reproducibility analog C-scans of FP/Mg coupon N4-3 with 2.54 mm (0.1 in.) gap fiber fracture.

Table 6 shows wave propagation velocities and wave attenuation coefficients for FP/Mg coupon N4-3 with 2.54 mm (0.1 in.) gap fracture (refer to Figure 33). The wave propagation velocity values correspond with the ultrasonic scanning inspection in showing the extent and presence of the gap fracture. The wave velocity values at inspection locations 3, 4, and 5 average 5% lower than the surrounding unflawed material. This in itself is not a very dramatic difference in wave velocity, but it must be taken within the context that the gap is at the mid-thickness of the coupon and involves only one of the eight fiber plies. The wave attenuation values are conflicting and inconsistent with respect to the wave velocity measurements and ultrasonic inspection C-scans. For coupon N4-3 with gapped fiber fracture, the wave propagation velocity data reservedly indicate the presence of the defect, but the wave attenuation coefficients do not give any consistent, reliable evidence for the presence of the gapped fiber fracture.

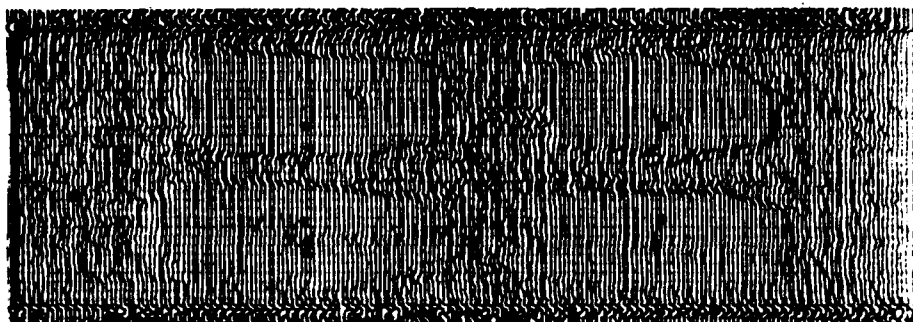
Figure 34. Ultrasonic attenuation inspection locations for specimen N5-1, fiber/matrix debonding (20 MHz C-scan).

Table 7 shows wave propagation velocities and wave attenuation coefficients for FP/Mg coupon N5-1 with fiber/matrix debonding. Both the velocity and attenuation values show clear correlation with the ultrasonic C-scans shown in Figure 34. At the indicated defects, the apparent wave velocity increases an average of 171% over the surrounding unflawed material, while similarly the wave attenuation coefficient increases an average of 425% over the surrounding unflawed material. The wave propagation is considered to be an apparent increase within the context of the defect type and measurement procedure. Because the debonding is at the mid-thickness of the coupon, it appears to have the characteristics of a tight delamination in that it presents a reflective surface for the ultrasound to return from towards the contact transducer. When the thickness gage is calibrated to the mechanical thickness of the coupon and an internal defect reduces the path length of the ultrasound, the result is an apparent drastic increase in the wave propagation velocity. Alternatively, a tight delamination significantly dissipates the amplitude of the reflected ultrasound which is indicated as a substantial increase in the wave attenuation coefficient. The change in wave attenuation coefficient for the fiber/matrix debonding (425%) is significantly different from that of porosity (110%) to uniquely characterize the difference between the two defects. For coupon N5-1 with fiber/matrix debonding, both wave velocity and attenuation coefficient values correlated with the presence of the defects as shown by ultrasonic inspection, and were of such a magnitude as to clearly qualify the defect as being different from all others evaluated in this program.

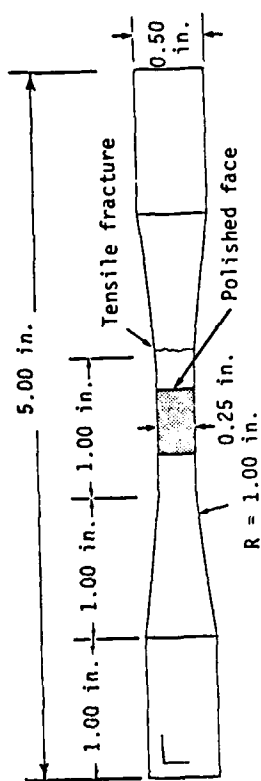
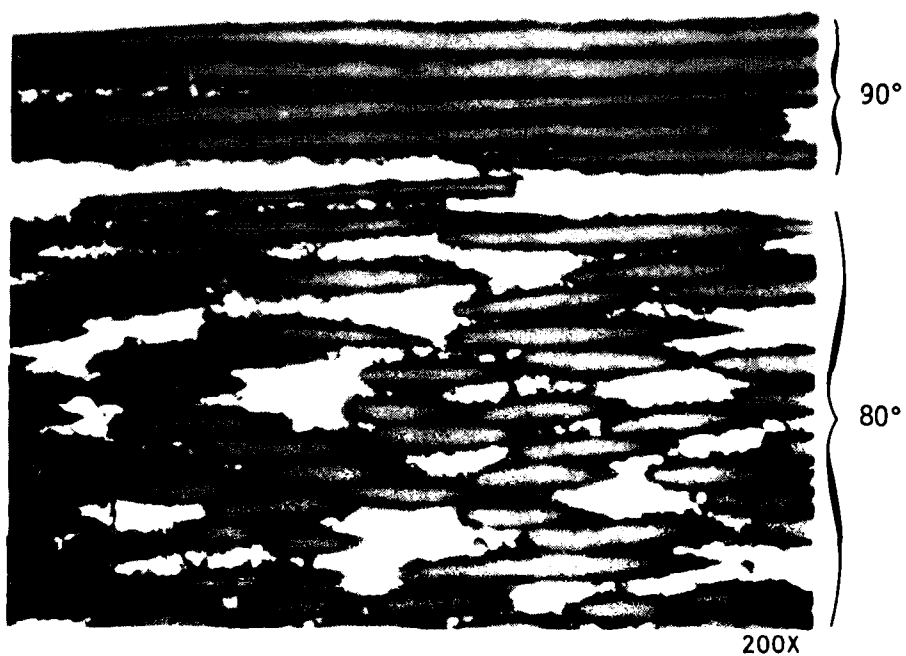
(a) Schematic showing the location of the transverse section removed for microstructural analysis from specimen N3-3-3.

(b) Optical micrograph of polished cross section of sample N3-3-3 showing the uniaxial/10° off-axis fiber interface

(c) Optical micrograph of fibers oriented 10° off-axis in sample N3-3-3.

Figure 38. Representative microstructure of type N3-3 ($\pm 10^\circ$ off-axis fibers) materials.

(d) Polished specimen N3-3-1 showing the uniaxial/ 10° off-axis interface normal to the tensile direction.

(e) Higher magnification of (d) above.

Microstructural analysis of samples containing off-axis fibers proved to be the most definitive technique for locating the material "defect." Transverse sections were removed from tensile samples and polished so as to see fiber diameter cross sections. Accordingly, $\pm 10^\circ$ off-axis fibers (Figure 38c) should form smaller ellipses than $\pm 20^\circ$ off-axis fibers (Figure 39c). Results showed that the 10° ellipses were not definitive by themselves, but only in relation to the 20° ellipses. The $\pm 10^\circ$ and $\pm 20^\circ$ off-axis specimens were then examined normal to the tensile direction. In this case, the longitudinal, uniaxial fibers were seen in lengthwise cross section. The off-axis fibers formed teardrop-shaped cross sections which corresponded to an 80° ellipse for the 10° off-axis fibers (see Figure 38e), and to a 70° ellipse for the 20° off-axis fibers (see Figure 39e). Samples prepared in this direction were fairly difficult to prepare due to fiber fracture along the fiber length.

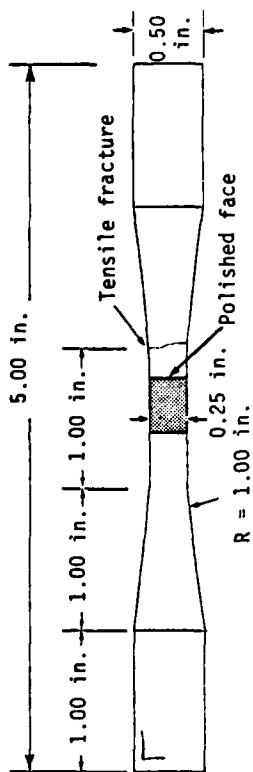
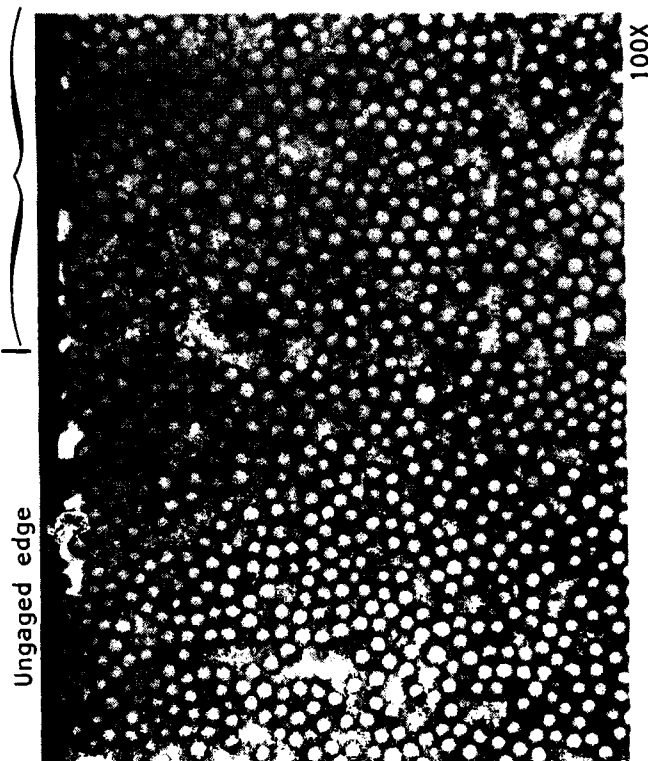
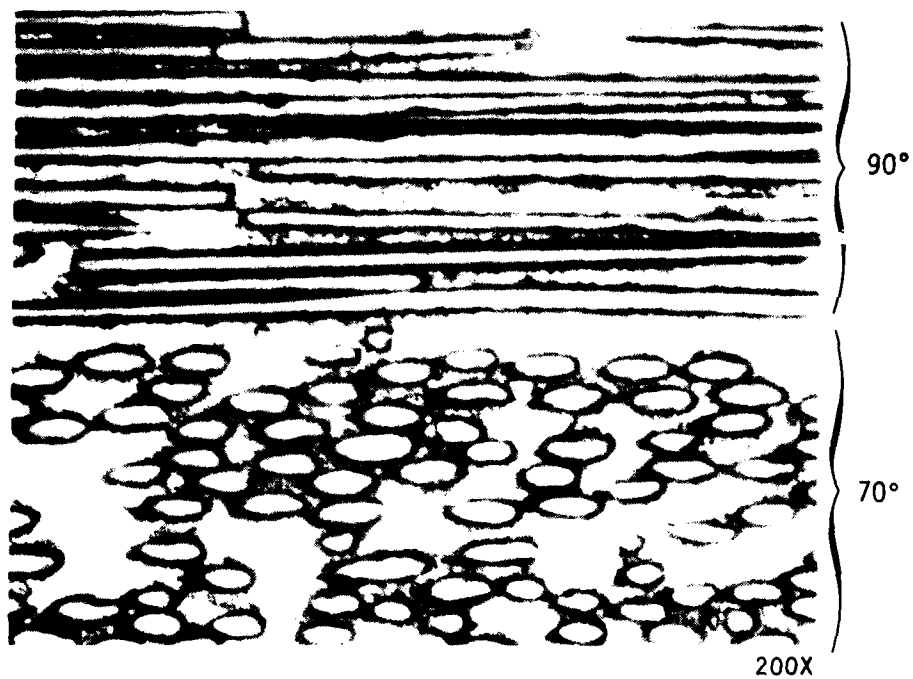
(a) Schematic showing the location of the section removed for microstructural analysis.

(b) Optical micrograph of polished cross section of sample N3-1-1 section showing the uniaxial/20° off-axis fiber interface.

(c) Optical micrograph of fibers oriented 20° off-axis in sample N3-1-1.

Figure 39. Representative microstructure of type N3-1 ($\pm 20^\circ$ off-axis fibers) material.

(d) Longitudinal polished section of specimen N3-1-2 showing uniaxial/20° off-axis interface (normal to the tensile direction).

(e) Higher magnification view of (d) above.

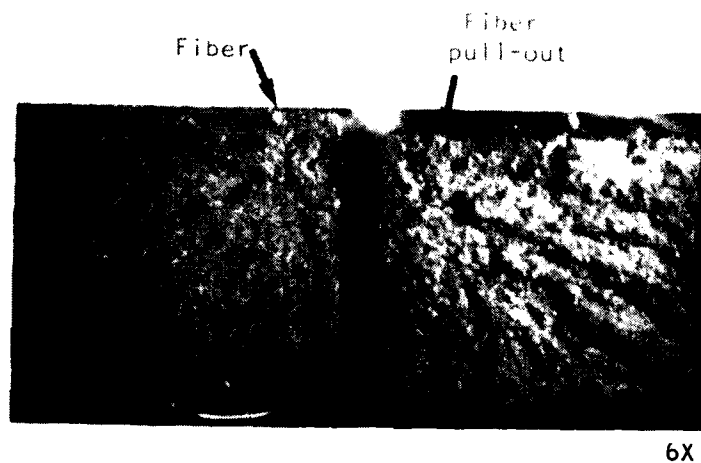
(a) Specimen 01-3-1 fracture surface indicating a large Al_2O_3 fiber fracture origin.

(b) Specimen 01-3-2 gage surface showing the misaligned Al_2O_3 fibers which were the fracture origin.

Figure 43. Representative fractures of Type 01 (unflawed) material tested in uniaxial tension.

Three unflawed samples were tested in tension. The fracture surfaces were fairly flat, having little fiber pull-out. Features similar to those found in brittle, monolithic materials were observed: a flat region near the origin and lines radiating outward from there. One sample (01-3-1) had an origin (near a corner just below the gaged surface) which appeared to be a large Al₂O₃ fiber. Sample 01-3-2 had a fracture initiating from misaligned fibers on the gaged surface where they intersected a corner. The last sample's origin was unidentified. Fracture surfaces are shown in Figure 43.

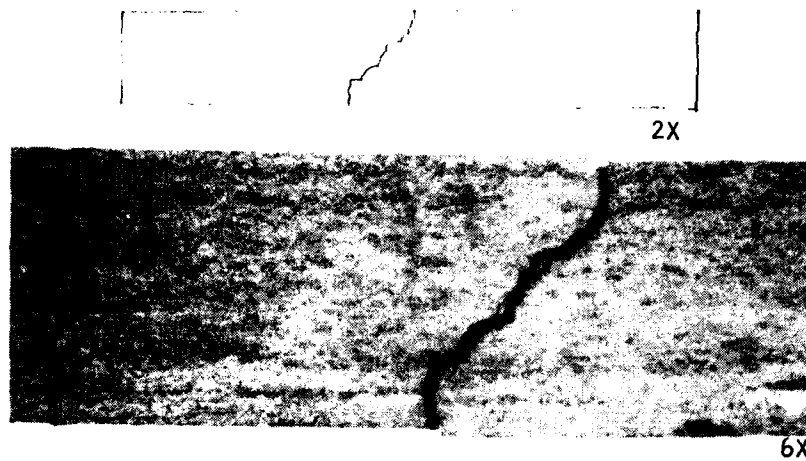
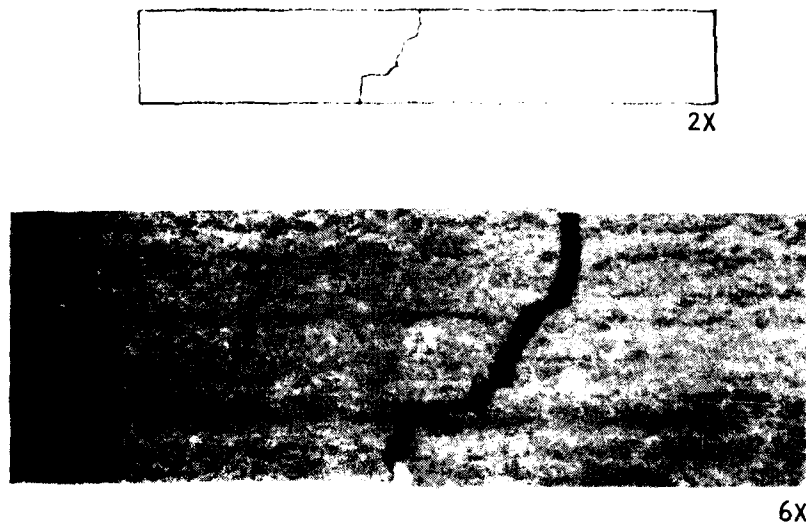
(a) Schematic and micrograph of specimen N1-4-5 cross section showing the crack path through regions of porosity.

(b) Schematic and micrograph of specimen N1-4-6 cross section showing the crack path deflection at and subsequent movement along a band of porosity.

Figure 44. Representative fractures of type N1 (porosity) material tested at 90° in 3-point flexure.

The billets of material containing porosity were tested in three-point flexure. Four samples were prepared from billet N1-3's unflawed region. Of these, three fracture origins were undetermined. The other sample contained a large Al_2O_3 fiber fracture origin similar to that of sample 01-3-1. Six samples from the flawed and four samples from the unflawed regions of billet N1-4 were examined after being broken in three-point flexure in two orientations. No fracture origins could be determined for the unflawed samples. Porosity was easily observable in the flawed samples; however, pores or pore clusters did not appear to act as fracture origins. Fracture surfaces of these 90° samples appeared "stepped" as the crack path moved from one region of high porosity to another. An example of a porous flexure specimen is shown in Figure 44.

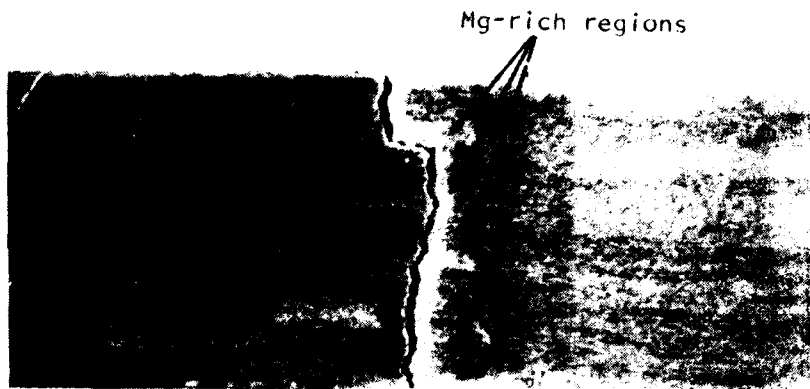
Figure 45. Representative fracture of type N2 material having nonuniform fiber distribution.

(a) Side view of specimen N2-2-3.

(b) Magnified view of (a) above showing the fracture path along the 55/35 volume percent fiber interface.

(c) Fracture surface (gaged surfaces together) showing the metal-rich region at the 55/35 volume percent fiber interface.

Tensile samples were machined from two billets (N2-2 and N2-3) containing nonuniform fiber distributions such that the volume interface boundary was within the gage section. The fracture surface analysis of these samples was straightforward since samples generally failed at the interface. Variation among samples occurred as to the extent of Mg-rich region that was visible on the fracture surface. That is, all samples failed at the transition region which varied in magnesium content somewhat from sample to sample. An example of the fracture surface of this type sample may be seen in Figure 45.
